Building Inspection Report

Monogram, Long Beach, CA

Inspection Date:
4/10/09

Prepared By:
Beachside Property Inspection, LLC
5318 E. 2nd St., #707
Long Beach, CA, 90803
ph. (562) 433-2288
fax: (562) 987-2424

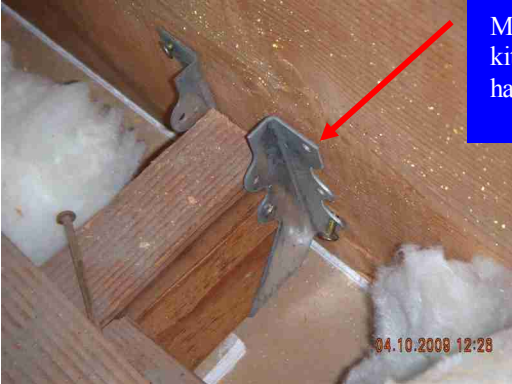
- **Improve/Safety Issue:** Improper fastening of the kitchen ceiling joist hangers noted. Various hangers are loose and are missing nails at connections; suggest further review by a licensed contractor prior to the close of escrow or contingency period.

Missing nails at kitchen ceiling joist hangers

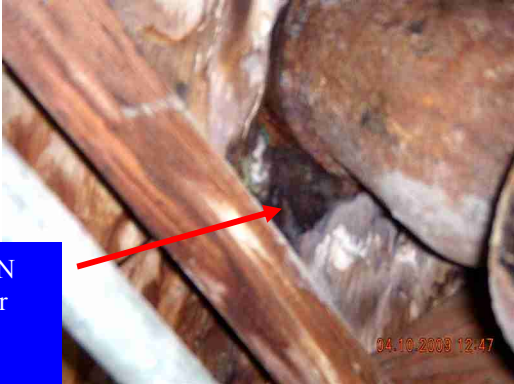
43. **Improve:** Damp framing noted at the lower N bathroom toilet sub -floor; suggest installation of a new wax ring and further review by a licensed structural pest control operator prior to the close of escrow or contingency period.

Dark damp area at N bath toilet sub-floor

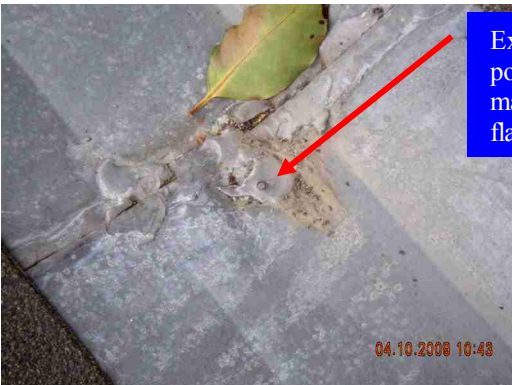
Exposed nail is popping through mastic at valley flashing

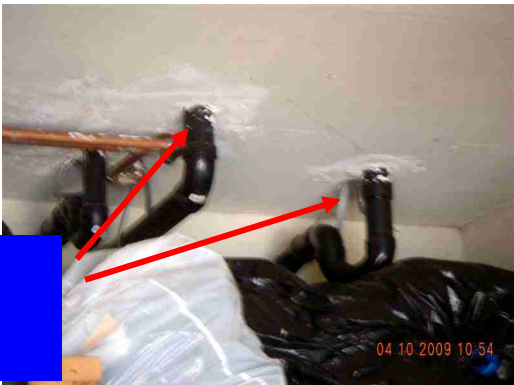
- **Safety Issue:** Proper fire separation between the garage and house proper is recommended. Missing fire -rated wall finishes noted at various locations below the upper hall bath (NE ceiling of garage) must be patched with “X -type”, 5/8ths of an inch, fire rated sheetrock. Further, any gaps should be filled and pipe penetrations sealed tight around their perimeter where they pass through the wall; suggest further review by a licensed contractor prior to the close of escrow or contingency period.

Plastic waste pipes passing through garage fire-rated ceiling finish

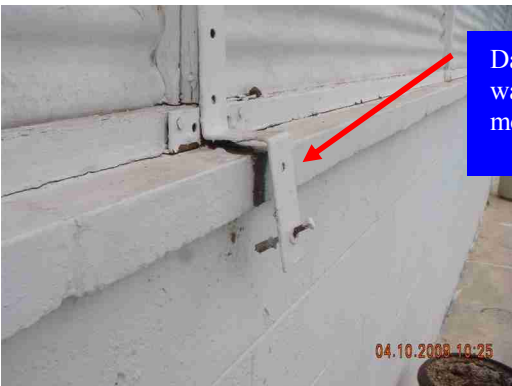
- **Improve:** Leaning sections noted at the S fencing. The N gates are loose; suggest improving.
- **Improve:** The block wall’s wooden privacy extension mounts are dilapidated/damaged; suggest removal/rebuild.

Damaged property wall privacy fence mount

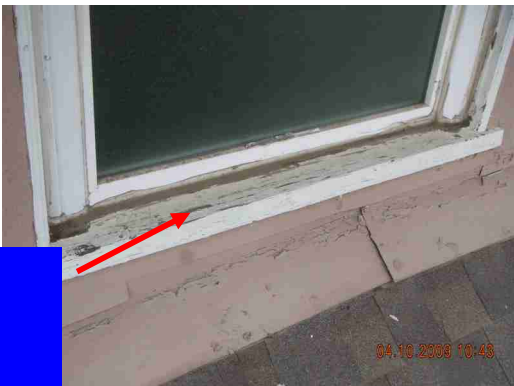
Paint deterioration

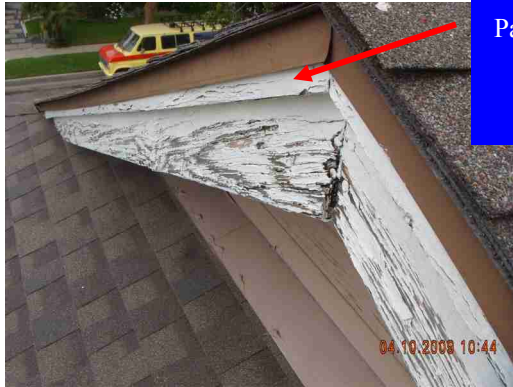
Paint deterioration

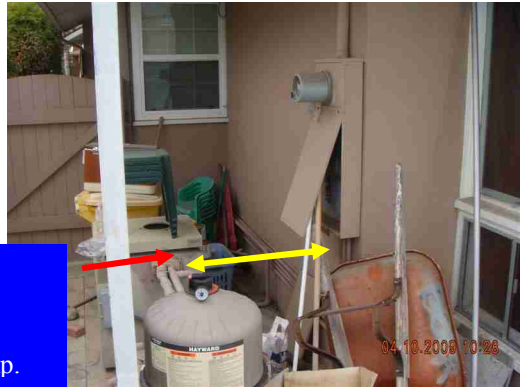
- **Major Improve:** Insufficient service clearance noted at the main and adjacent branch electrical panels. The pool equipment is within the 3 -feet of frontal clearance area required; suggest further review by a licensed pool contractor prior to the close of escrow or contingency period. The pool equipment should be re-located.

Insufficient service clearance provided between electrical panels & pool equip.

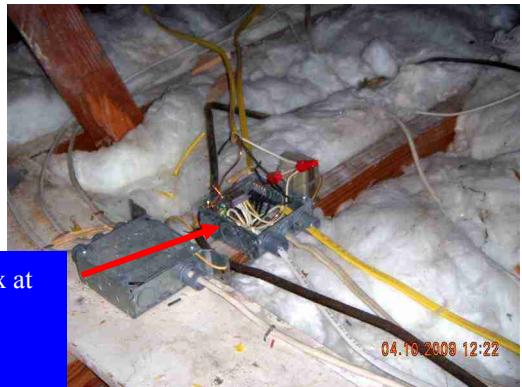
- **Safety Issue:** Multiple open electrical junction boxes noted at the lower level attic. All visible wiring connections should be enclosed within ***covered junction boxes***; suggest conforming installation. A common reason for missing junction box covers is an overfilled box. If this is the case, an extension ring can be added to provide extra cover clearance; suggest further review by a licensed electrical contractor prior to the close of escrow or contingency period.

Open electrical box at attic

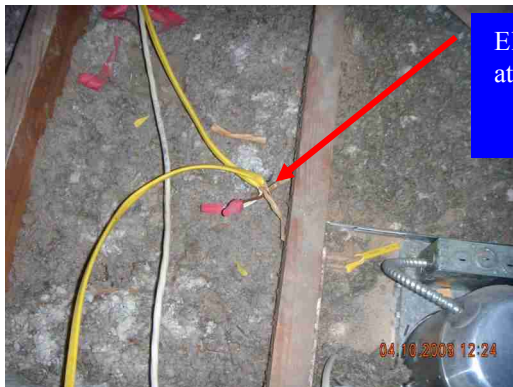
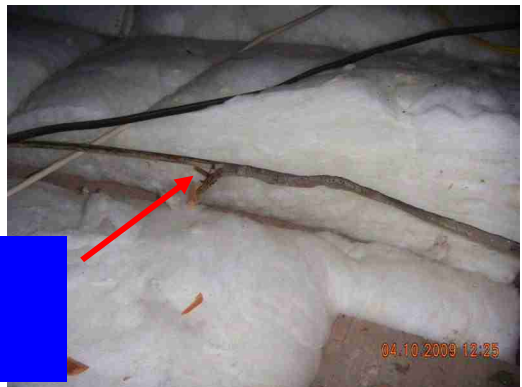
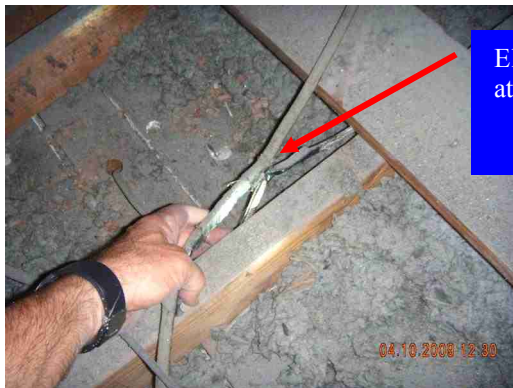
- **Safety Issue:** Multiple running electrical splices noted at the lower level attic space (kitchen and S bath areas); all electrical connections should be made within covered junction boxes; suggest conforming installation.

Electrical splice at attic

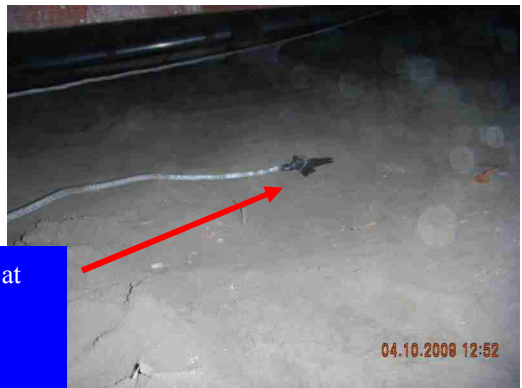
- **Improve/Safety Issue:** Improper termination of disconnected electrical conductors noted at the family room SE corner, N hallway and kitchen crawl spaces. All terminated/abandoned conductors should be enclosed within covered junction boxes or the conductors removed altogether; suggest conforming installation.

Abandoned wiring at crawl space

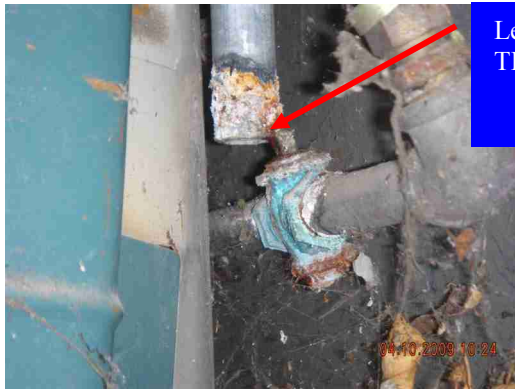
31. **Improve:** The Temperature and Pressure Relief (TPR) Valve serving the water heater is leaking; suggest further review by a licensed plumbing contractor prior to the close of escrow or contingency period.

Leak at water heater TPR discharge pipe

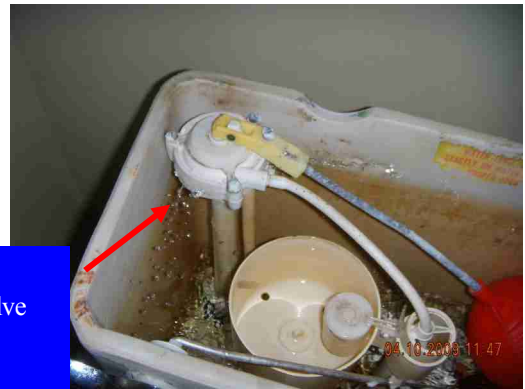
25. **Improve:** Leak noted at the upper hall toilet tank filler float valve; suggest further review by a licensed plumbing contractor prior to the close of escrow or contingency period.

Leak at upper hall toilet tank filler valve

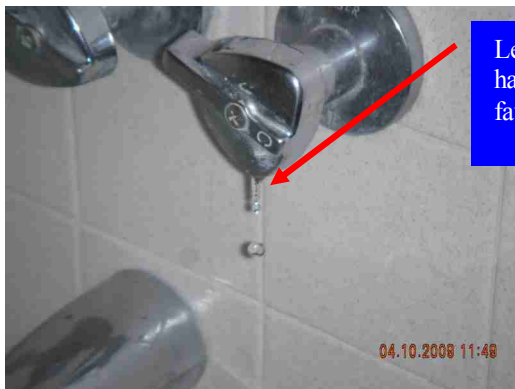
Leak at upper level hall shower cold water faucet

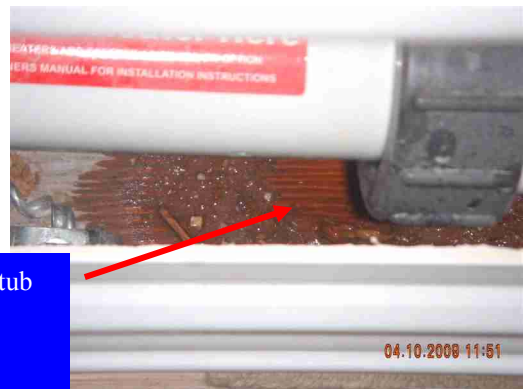
24. **Improve:** Leak noted at the whirlpool tub jet plumbing; suggest further review by a licensed plumbing contractor prior to the close of escrow or contingency period.

Leak at whirlpool tub jet plumbing

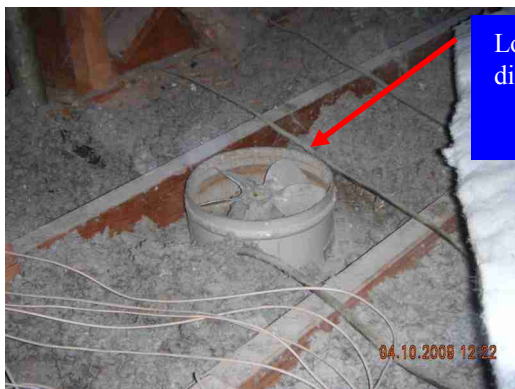
23. **Improve/Safety Issue:** Both of the lower level bathroom ceiling exhaust fans vent directly in to the attic space (allowing moisture into a confined area and compromising the fire -rating of the living space). The fan should be provided with a flexible/rigid metal duct terminating at an exterior vent; suggest improvements.

Lower bathroom fans discharge to the attic

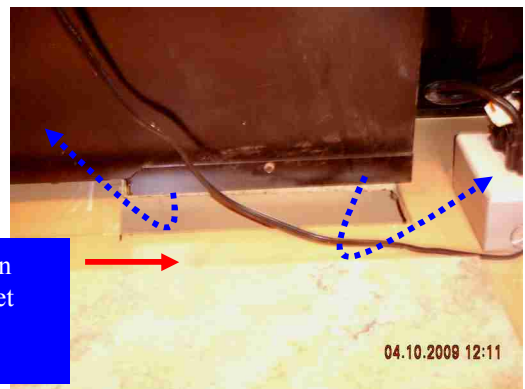
Kitchen exhaust fan discharge to cabinet
