# Building Inspection Report

## Hermosa Beach, CA

**Inspection Date:**  
2/15/19 10:00am

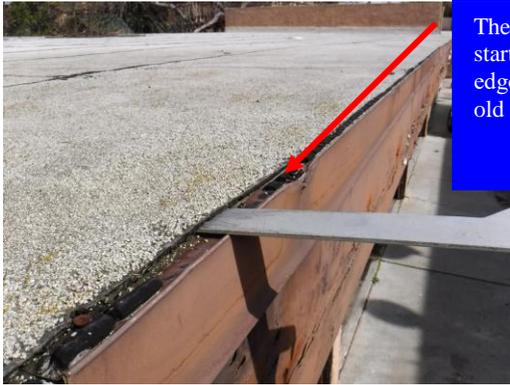
The garage roof is also starting to lift off the S-edge metal...a sign of an old roof

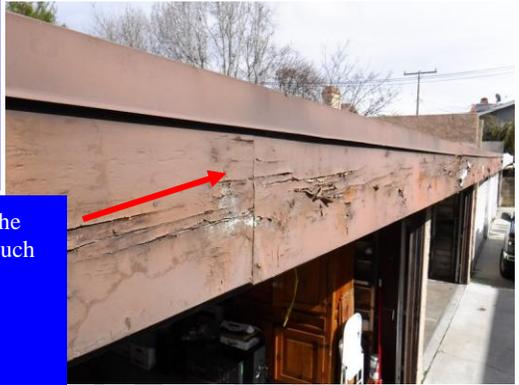
The wood throughout the property is weathered such as here at the garage fascia...

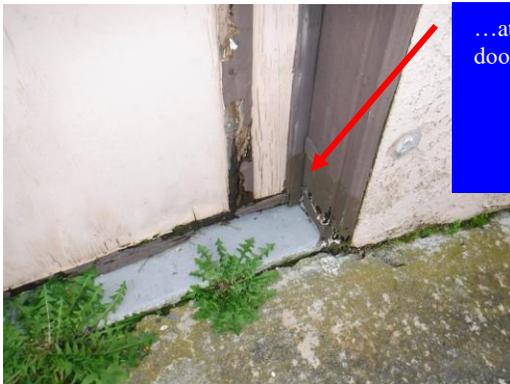
...at the D Unit vehicle door and stucco trim...

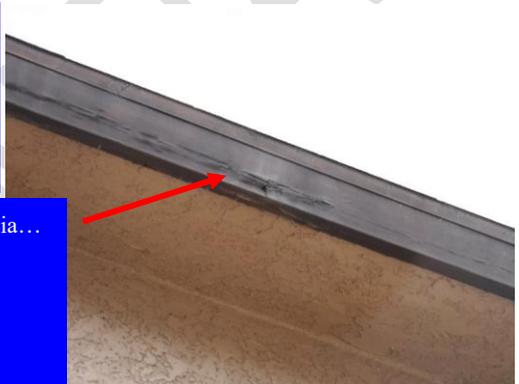
...at the multi-unit fascia...

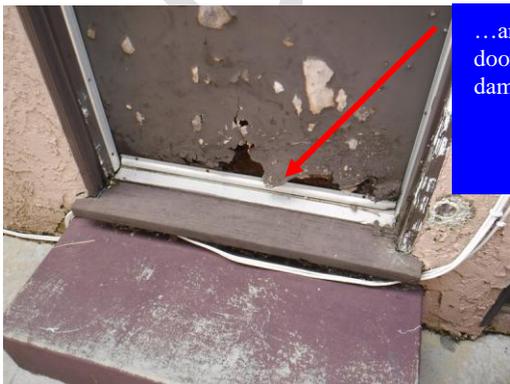
...from delaminating, blisters and damaged stucco trim

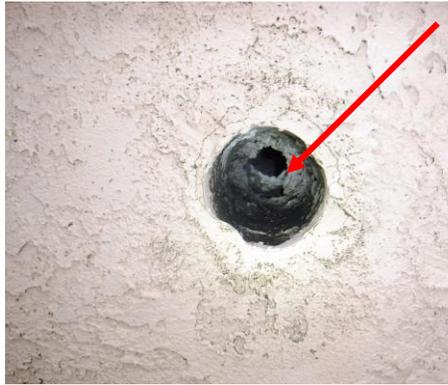
The D Unit clothes dryer duct lacks an exterior terminal and is packed with lint

21. **Improve:** The 'D' Unit's clothes dryer exhaust duct's exterior termination is missing a back draft cover; suggest improving.
22. **Improve:** The 'House' electrical panel was not located or inspected and should be reviewed by the same licensed electrical contractor tending the other issues cited in this report.

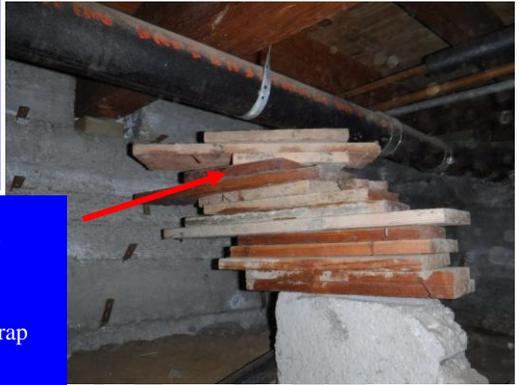
The crawl space waste piping has a number of issues from improper support where stacked scrap lumber is atop scrap concrete...

24. **Improve:** The crawl space waste piping exhibits a few issues that can obstruct drainage, where the pipes are improperly supported, etc. The N-crawl space area ('D' Unit kitchen) waste piping is supported atop a stack of scrap lumber, the waste piping below the 'C' Unit kitchen has reversed slope, rubber coupler fittings at ABS-to-cast iron waste pipes connections require corrugated metal jackets to prevent off-sets at the connections (an offset was noted at the 'C' Unit lower bath crawl space) and "Sanitary tee" fittings installed lying on their backs were noted at the 'A' Unit laundry area and kitchen (the steep, short sweep of these fittings do a poor job of transitioning vertical waste water flow to horizontal runs). Compounding these issues are the pin-hole leaks noted at a number of older cast iron pipes and that newer ABS pipe sections indicate this system is aging-out; suggest repairs by a licensed plumbing contractor. **Note:** This system should be camera inspected prior to the close of escrow or contingency period.

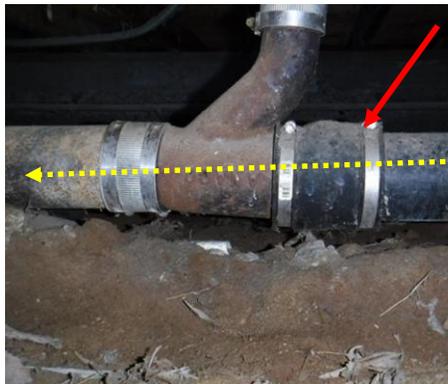
...where rubber couplers lacking steel jackets are used causing off-sets (here a slight reversed slope at the C unit bath area)...

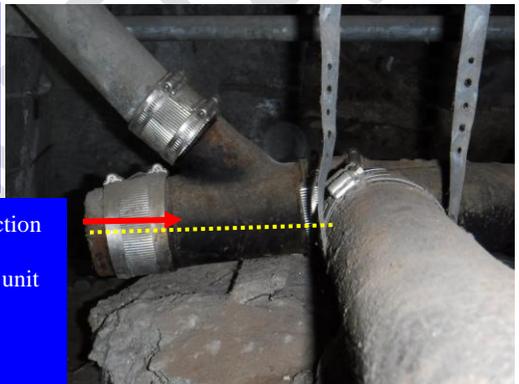
...and an older pipe section has deflected causing reversed slope at the C unit bath area...

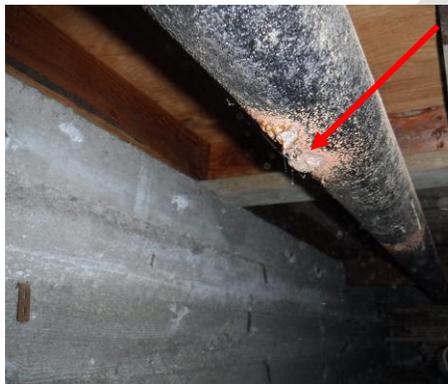
...as well, the older cast iron waste piping shows pin-hole leaks...

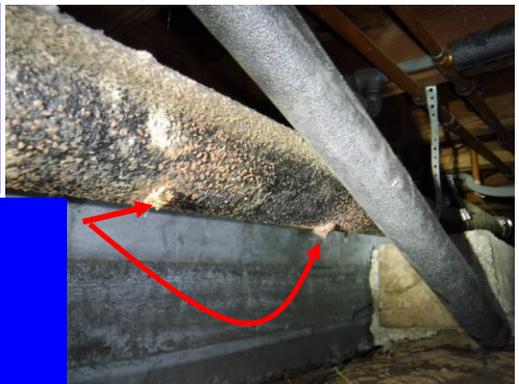
...and rust blossoms

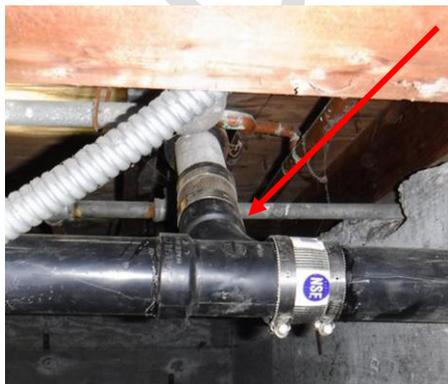
Repairs were also made where 'sanitary-t' fittings are used...

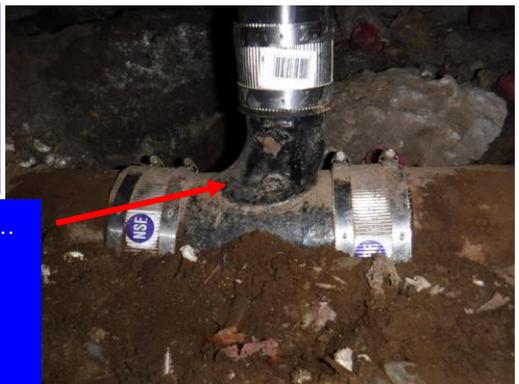
...lying on their backs...

...that can slow drainage

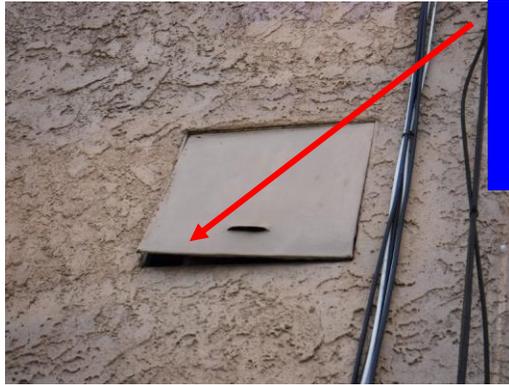
The building has a number of plumbing access hatches that are not seated and allow nuisance pest or water entry

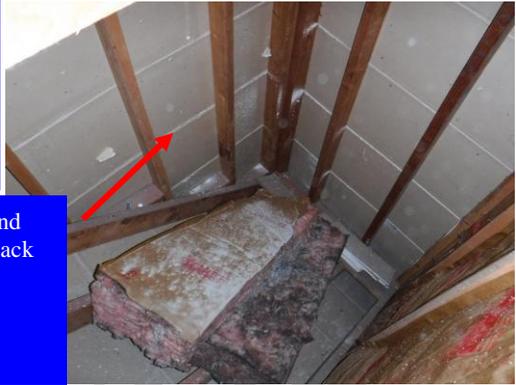
The attic areas above and abutting the stairways lack insulation

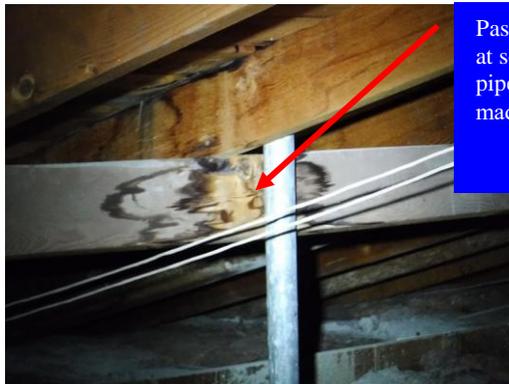
Past roof leaks were noted at some attic areas where pipe penetrations are made...

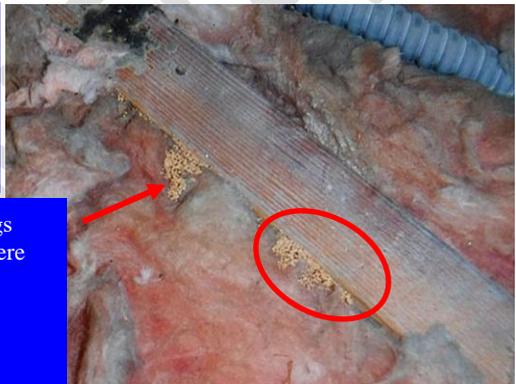
...and termite droppings were noted here and there

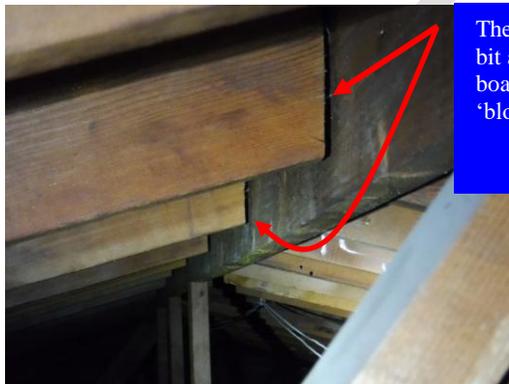
The rafters have pulled a bit away from the ridge board where additional 'blocking' may be desired

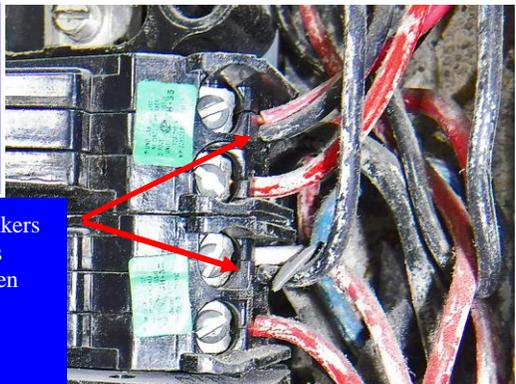
7. **Safety Issue:** The ‘A’ Unit electrical panel has two sets of circuits that are doubled up (referred to as “double taps”) to two breakers that must be separated achieve sufficient fastening torque and prevent overheating; suggest repairs by a licensed electrical contractor.

Unit A: two of the breakers have sets of conductors landed at their lugs when only one conductor is allowed

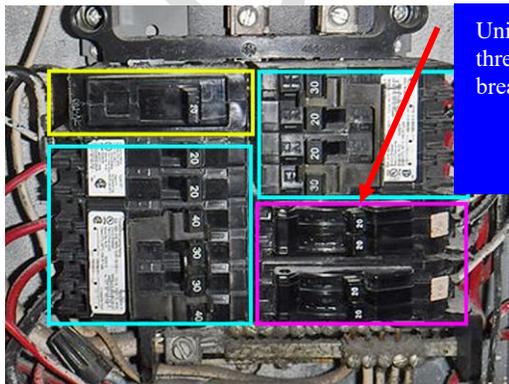
6. **Safety Issue:** Some breakers within the B & C electrical panels are of different models/makes from the balance of the breakers and have slight variations of shape and fit within the panel. The ‘B’ Unit panel breakers are actually bulging away from the bussing bar and may well have compromised fitment where arcing can occur; suggest further immediate review and repairs as needed by a licensed electrical contractor. Each breaker must be listed for these panels as substituting improper breakers can require on-site modifications to the back of the breaker housing to jam it into place.

Unit B: This panel has three different types of breaker models...

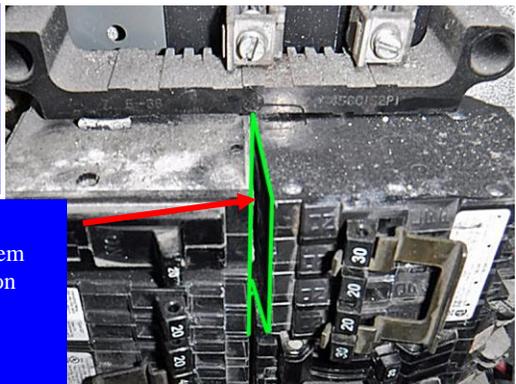
...resulting in a wedge shaped gap between them due to poor fitment upon the bussing

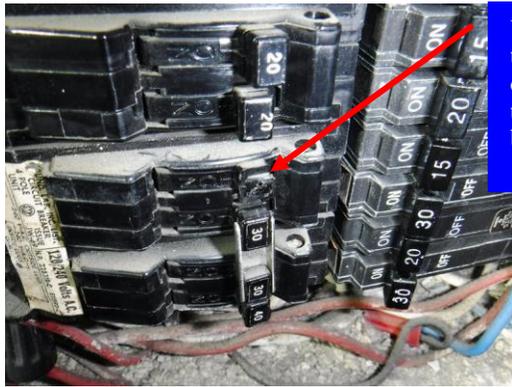
9. **Safety Issue:** The ‘C’ Unit electrical panel has a 120V breaker with a damaged toggle and lacks a ‘link bar’ at the 30-amp/240V breaker set that joins the two toggles together. This ensures that the entire circuit is shut off whenever a breaker is tripped or operated; suggest repairs by a licensed electrical contractor as the lack of a link bar presents a shock hazard.

Unit C: A breaker toggle handle is damaged, the panel has two different models of breaker...

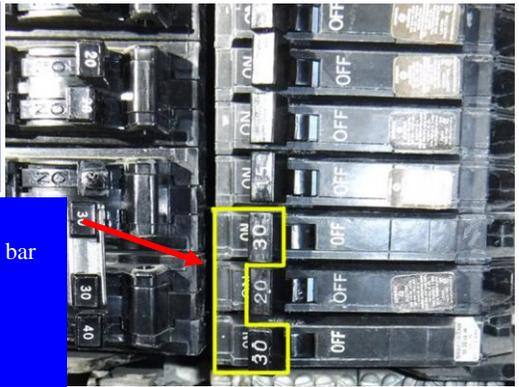
...and a 30amp/240V breaker-set lacks a link bar joining the toggles

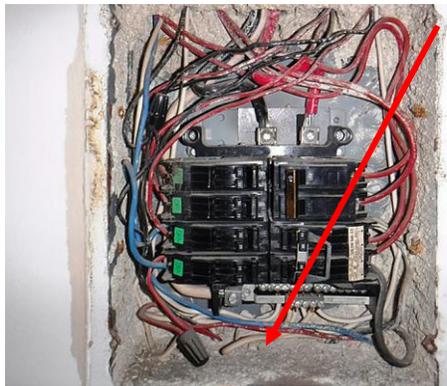
Many panels are full of wall putty, paint, etc

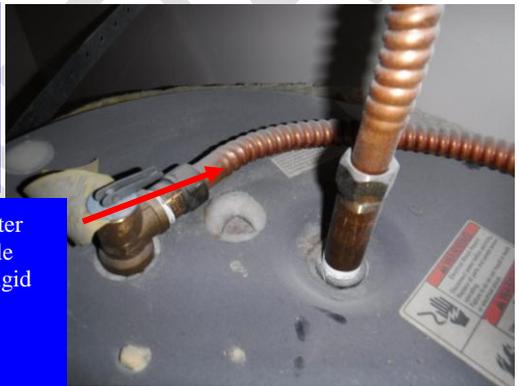
Unit A: The water heater TPR valve has a flexible drain pipe when only rigid is allowed...

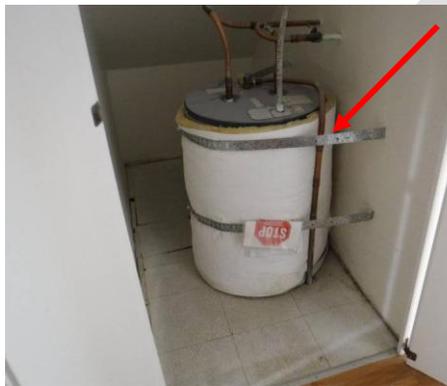
...and the seismic straps may not be over insulation blankets...

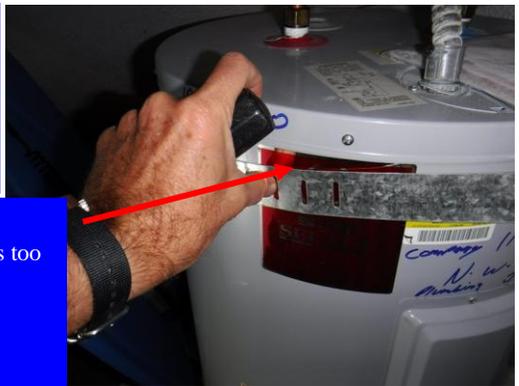
5. **Safety Issue:** Improper strapping of all four water heaters noted (units can be rocked, upper strap too high, no blocking behind the tanks, off-set wall anchors, wrapped over and insulation blanket, etc.). Water heaters in seismic zones must be double-strapped **snug to the wall (and if needed provided ‘blocking’ material between the tank and wall to prevent the unit from falling back).** The straps should be 1½ to 2” wide and located at the top and bottom third of the unit (**the upper strap should be no closer than 9-inches from the top or bottom of the unit) to resist any horizontal movement** during earthquake conditions. Note: **The straps should encompass the tank, each of the four separate strap ends secured to the 1<sup>st</sup> studs that are not directly behind the unit that should be centered between the wall anchors, mounted below insulation blankets** and not cover the water heater manufacture’s date plate; although strapped, the **boldface underlined** sections above require improvement.

Unit B: Like all of the tanks, the upper strap is too high and loose

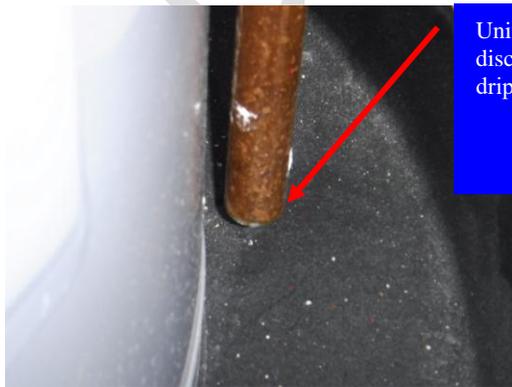
Unit C: The TPR valve discharge pipe drains to the drip pan...

20. **Improve:** The 'C' Unit water heater Temperature Pressure Relief valve's discharge pipe may not drain to the provided drip pan. The pipe must be routed to the exterior and face down between 6" & 24" above grade at a (preferably) conspicuous location; suggest repairs by a licensed plumbing contractor.

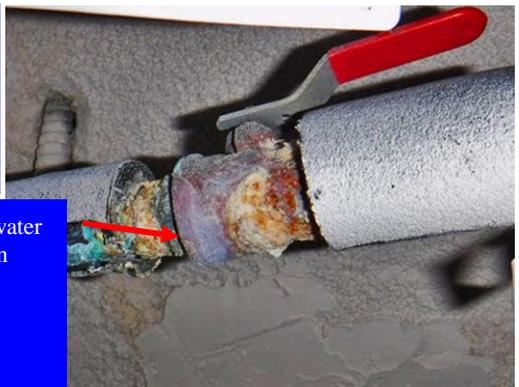
...and the tank's cold water valve exhibits corrosion

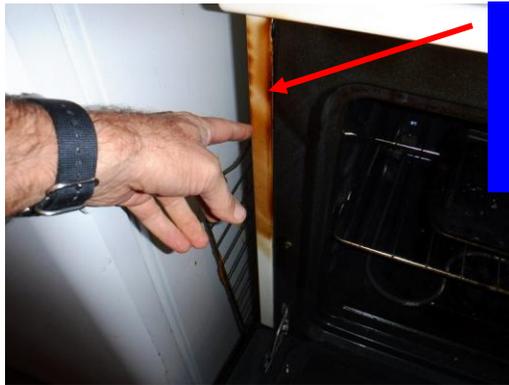
7. **Improve:** The electrical range is old, dirty and the oven door is missing its gasket where escaping oven heat has damaged the paint (and darkened the paint at the abutting refrigerator).

...the oven door gasket is missing resulting in scorching paint...

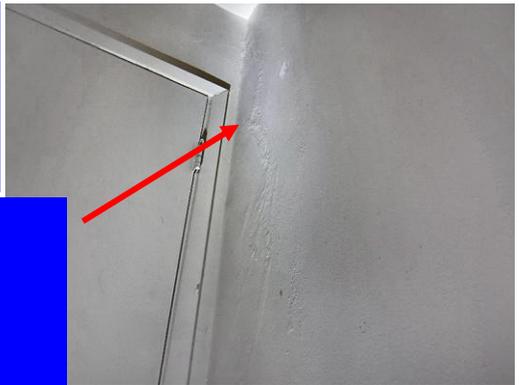
...water damaged wall finishes were noted adjacent to the kitchen exterior door...

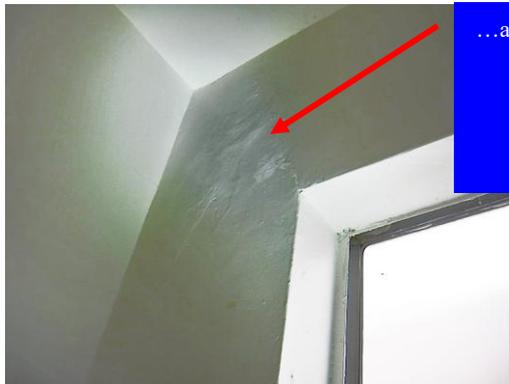
...and at the lower bath...

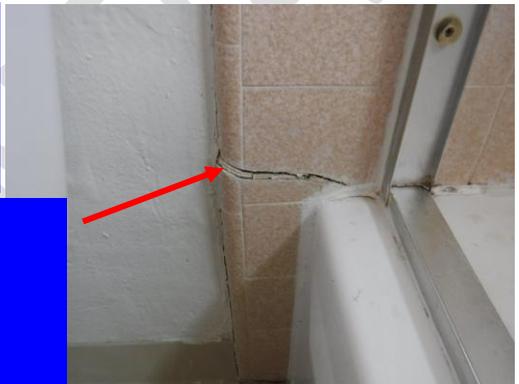
...the tub area shows damaged tile and wall repairs

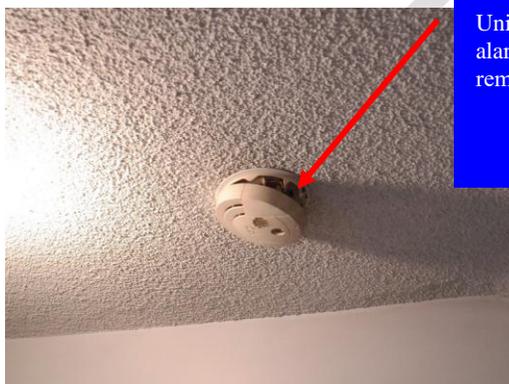
1. **Safety Issue:** A smoke and carbon alarm is needed at the lower level living area and a carbon alarm is needed at the upper hallway. Further, the upper hallway smoke alarm appears to have its battery removed. Smoke alarms were noted at both bedrooms.

Unit C: The hall smoke alarm battery has been removed...

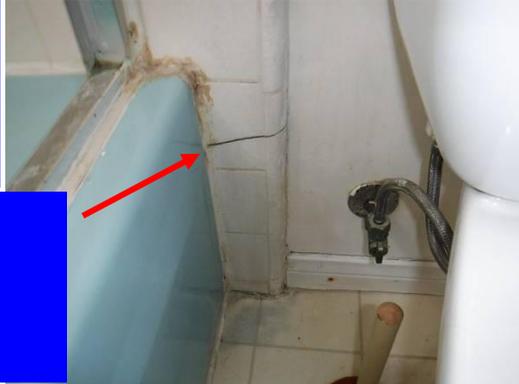
...the tub area shows damaged tile and wall repairs...

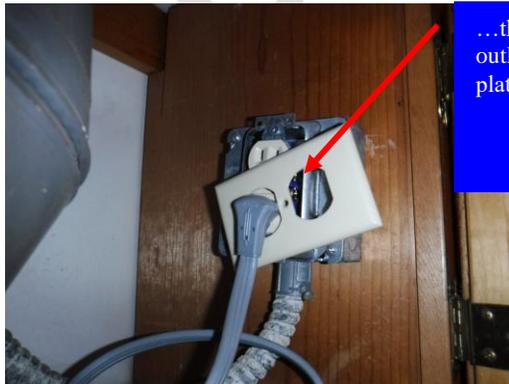
2. **Safety Issue:** The kitchen exhaust hood outlet cover plate is damaged/off-set.
3. **Improve:** The kitchen sink cabinet shelf exhibits damage & stains consistent with past water exposure that may have created conditions where hibernating organics exist at inaccessible areas. Areas of past moisture intrusion or current leakage often create conditions that are favorable for the growth of many fungus-like organisms (bacteria, mold, mildew, fungus and many other types of growth) that comprise indoor air quality. Damaged/stained materials should be replaced and/or the stained areas covered with an approved brush/roller application of mold encapsulating/neutralizing paint/surface treatment by licensed specialists following established protocols to assure organics do not 'kick-off' if re-wetted. Inspection for and identification of these conditions is beyond the scope of the CREIA Standards of Practice and would require consultation with an environmental specialist or licensed/Certified Industrial Hygienist.

...the kitchen exhaust fan outlet has a loose cover plate...

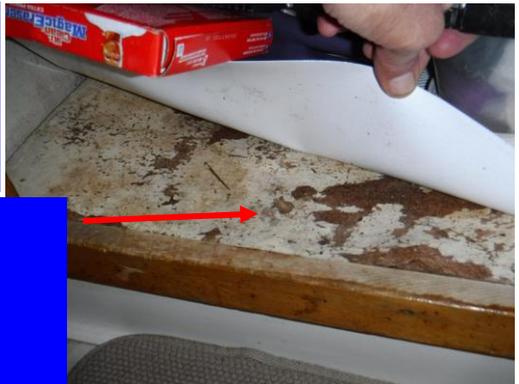
...and the kitchen sink shelf shows extensive water damage

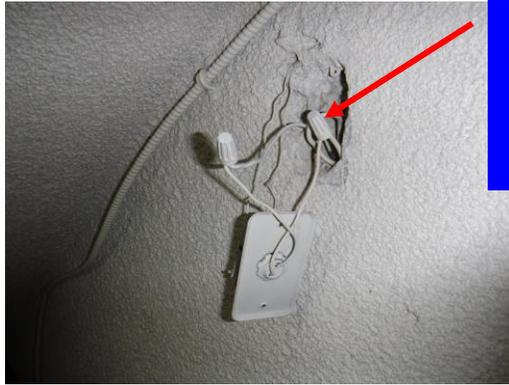
3. **Safety Issue:** The stairway closet has exposed wiring and connections at door bell transformer and light fixture within the stairway closet that present shock & fire hazards; suggest repairs by a licensed electrical contractor.

Unit D: The stairway closet has exposed wiring and connections at the door bell transformer...

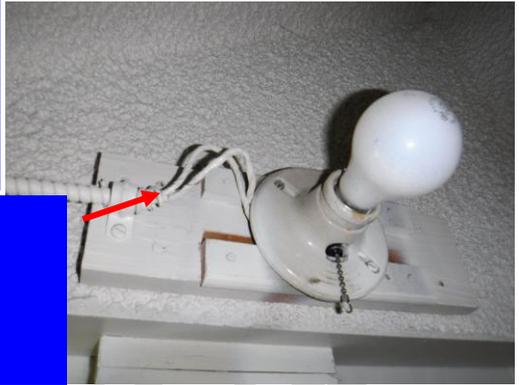
...and closet light...

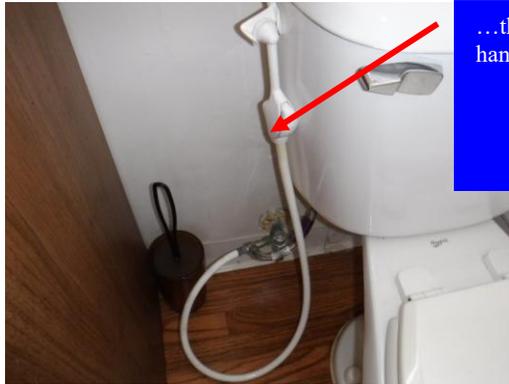
2. **Safety Issue:** The toilets have added personal hygiene hand sprayers lacking 'back-flow' protection to prevent a waste water/potable water cross connection and the upper unit has a damaged valve that allows constant discharge from the sprayer that require it be extended to the tub (otherwise it would flood the bathroom). These fixtures must be removed by a licensed plumbing contractor.

...the toilets have added hand operated sprayers...

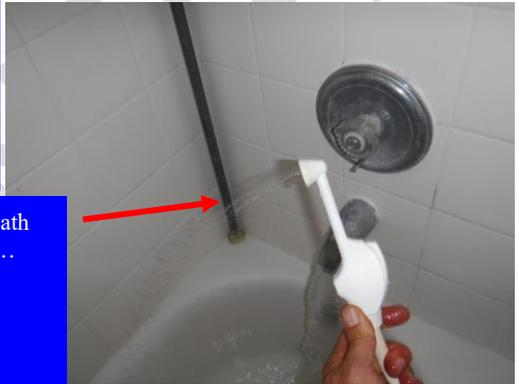
...of which the upper bath unit runs continuously...

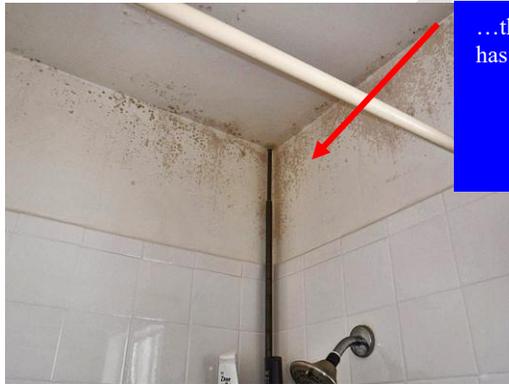
...the tub/shower enclosure has surface mildew...

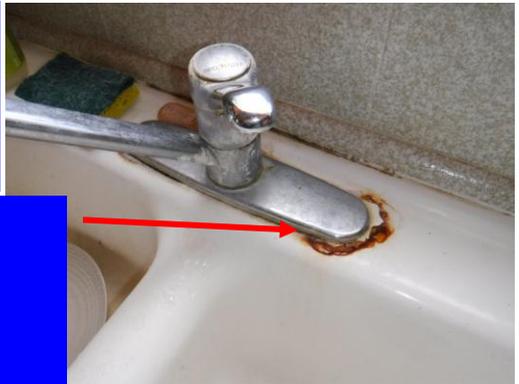
7. **Monitor/Improve:** The kitchen sink deck exhibits corrosion at the faucet mount area.

...and the kitchen sink deck exhibits rust
