# Building Inspection Report

## Hermosa Beach, CA

**Inspection Date:**  
2/15/19 10:00am

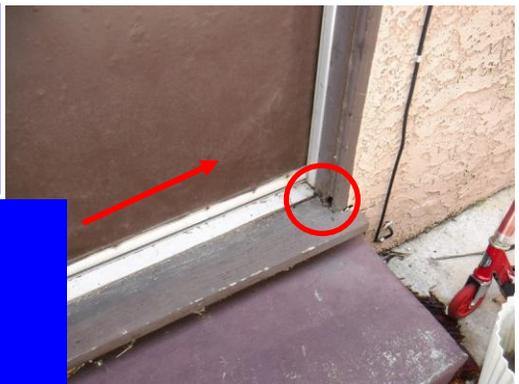
...and the kitchen exterior doors show extensive damage...

...from delaminating, blisters and damaged stucco trim

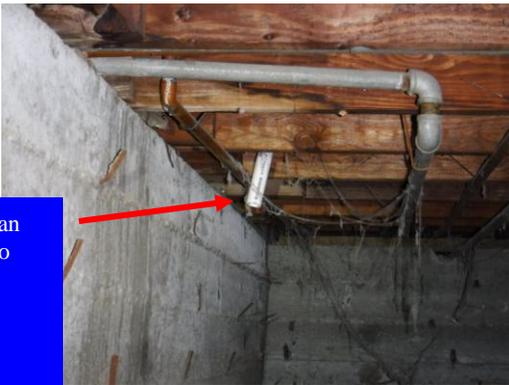
The water heater drip pan drains are discharging to the crawl space...

...when they must be routed to the building exterior

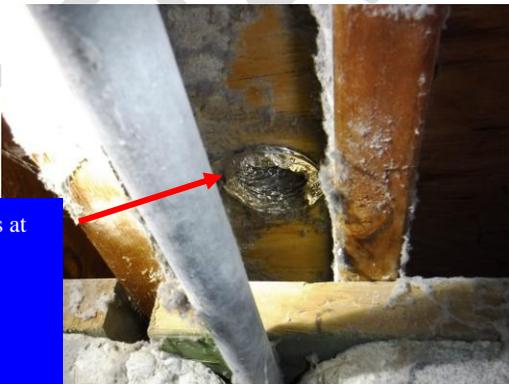
The dryer exhaust ducts at Unit's A, B & C all discharge to the crawl space...

...that must be routed to the building exterior

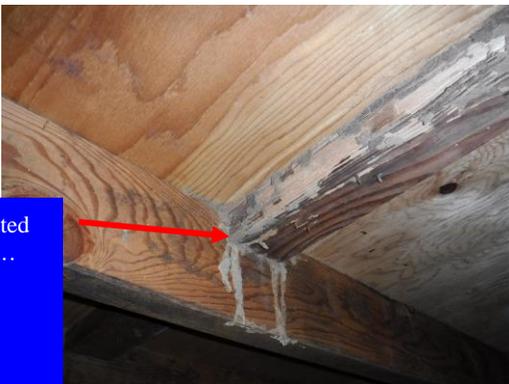
Termite activity was noted at the D Unit sub-floor...

...that requires action

16. **Improve:** Evidence of wood destroying insect activity was observed at the attic and crawl space; suggest further review by a licensed structural pest control operator prior to the close of escrow or contingency period.

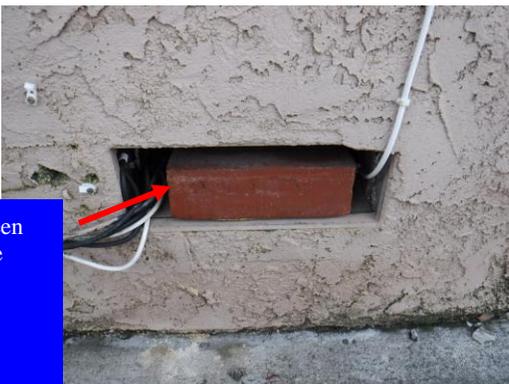
A crawl space vent screen at the NW-corner of the home is missing
